BUILDING 4290

CONDITION SURVEY DATA SHEET

CONDITION SURVEY

POST HOSPITAL

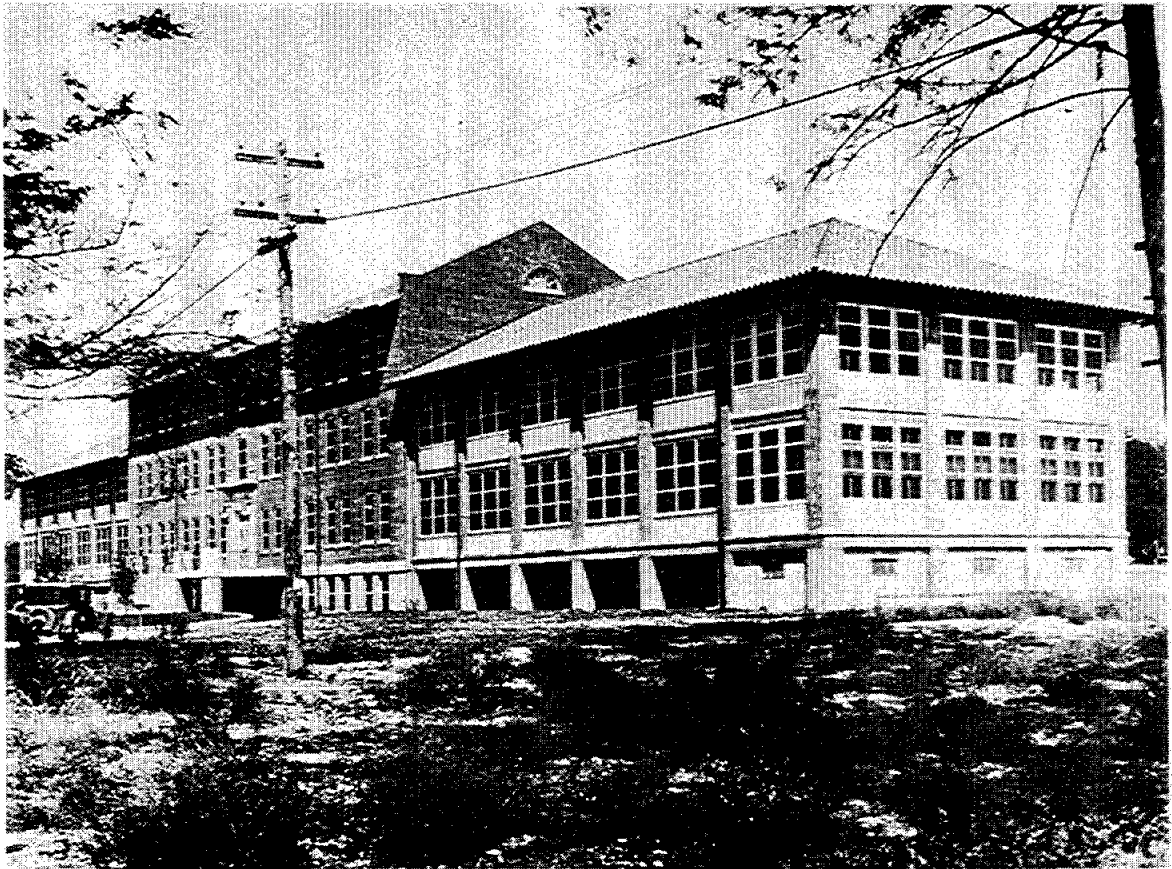
Building 4290 (formerly 140) was constructed in 1929 as the Post Hospital. Three wings were added shortly thereafter and another two wings were added in 1940. These were designed for future expansion; the rebars and corbels still project beyond the "temporary" stucco wall.

The building is symmetrically designed and contains two interior courtyards. It's primary facade now faces Interstate 5. The main entrance is now unclear, with most users entering the building from the side and rear nearest the parking lot. Signage could be improved. The building now serves as a clinic extension for Madigan Hospital.

The gracious entry doors were removed in 1966. In 1970, the building suffered fire damage resulting in the replacement of the north wing tile roof. The color difference is obvious. The building is in good condition.
